MANDATORY SERVICE BULLETIN

DATE: March 8, 2012 Service Bulletin No. 602
Engineering Aspects are
FAA Approved

SUBJECT: Incorrect Part Numbers on Service Instruction No. 1098G

MODELS AFFECTED: IO-540-AB1A5 or its applicable crankshaft that had propeller flange bushings replaced in the field in accordance with Service Instruction No. 1098G

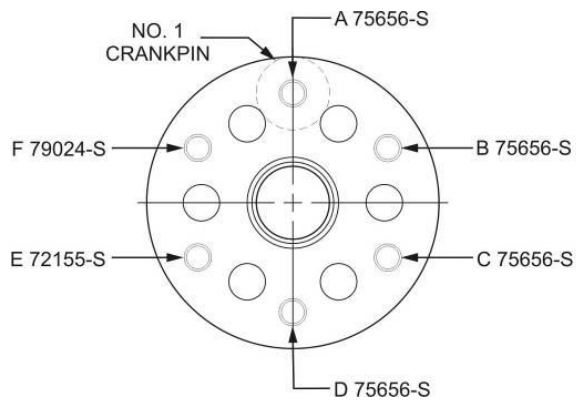
This Service Bulletin is notification that the propeller flange bushing part numbers for engine model IO-540-AB1A5 were misidentified in revision G of Service Instruction No. 1098. Service Instruction 1098 identifies part numbers for propeller flange bushings and the locations (A, B, C, D, E, and F) of where respective bushings are to be installed on the propeller flanges.

Figure 1 of this Service Bulletin shows the location of the propeller flange bushings as per Service Instruction 1098G (which is incorrect).

Figure 1
Incorrect Part Number and
Location of Propeller Flange Bushings

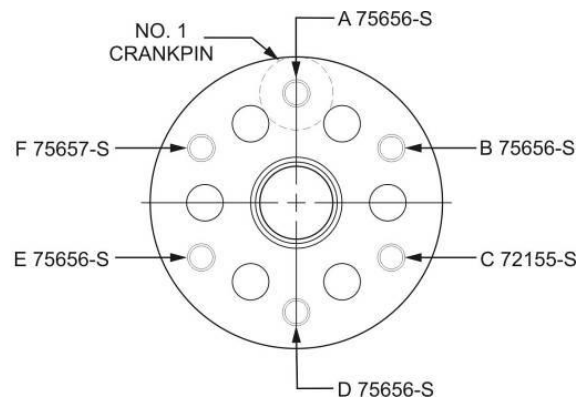
Figure 2 and the information below identify the correct propeller bushing part numbers and locations for the installation of propeller flange bushings on the IO-540-AB1A5 engine model.

Figure 2
Correct Part Number and
Location of Propeller Flange Bushings

1. Examine the bushings from the backside of the crankshaft flange to make sure that the bushings are not displaced (pushed back).
2. If any of the bushings are displaced, remove the propeller flange bushings.
3. Install the correct propeller flange bushings with the correct part number (Figure 2) in the corresponding locations.

- A. 75656-S
- B. 75656-S
- C. 72155-S
- D. 75656-S
- E. 75656-S
- F. 75657-S
