MANDATORY

SERVICE BULLETIN

Service Bulletin No. 366C
(Supersedes Service Bulletin No. 366B)
Engineering Aspects are
FAA Approved

SUBJECT: Carburetor Throttle Body Screw Inspection

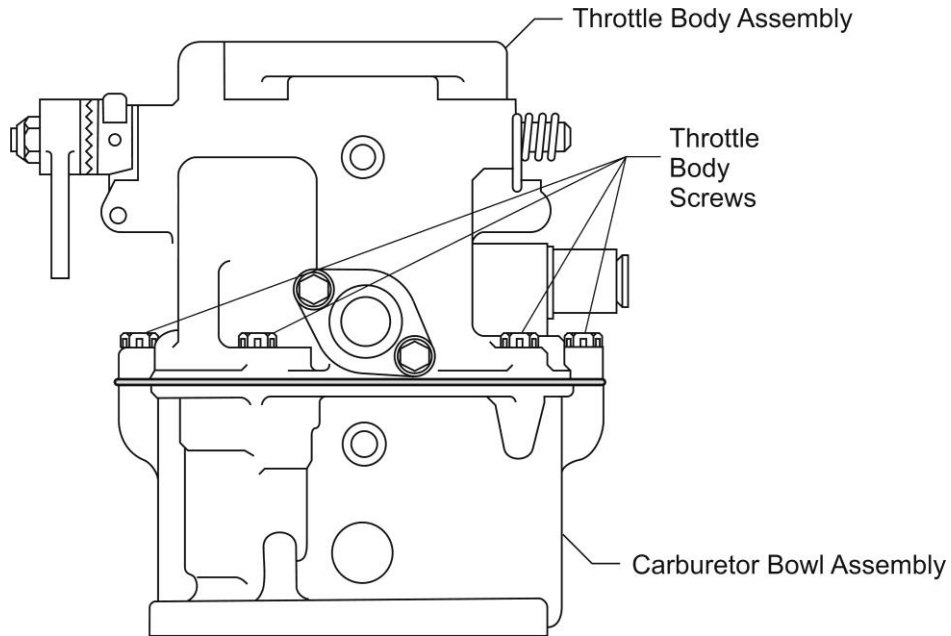
Figure 1
Illustrative Example of Throttle Body Attaching Screws

Instances have been reported of leakage through the gasket between the bowl assembly and throttle body of the carburetor, evident by fuel stains in the area of the leak. Leakage of this type can be accompanied by loose screws that attach the bowl and throttle body.

Models MA-3A, MA-3PA, MA-3SPA, and MA-4SPA have four screws. Models MA-4-5, MA-4-5AA, and MA-6AA have six screws.

1. Examine the carburetor for evidence of fuel stains on the outside of the bowl along the parting line.
2. Complete a check for movement between the throttle body and bowl.
3. Make sure each throttle body-to-bowl attaching screw is secure and not loose by attempting to move the screw and/or locktab washers with your fingers.

4. If there is evidence of fuel stains, movement between the throttle body and bowl, or the throttle body-to-bowl attaching screws are loose then remove the carburetor in accordance with the applicable engine and airframe service manuals. Send the carburetor to a qualified repair station for troubleshooting and repair. Reinstall the carburetor in accordance with the applicable engine and airframe service manuals.
5. Make an appropriate logbook entry showing compliance with this Service Bulletin.
