SERVICE BULLETIN

DATE: January 8, 2025 Service Bulletin No. 658
 Engineering design data in this service document is FAA approved.

SUBJECT: Starter Inspection, Hartzell Engine Tech (HET) Service Bulletin (SB) No.211

Aircraft Starter Power-Lead Inspection

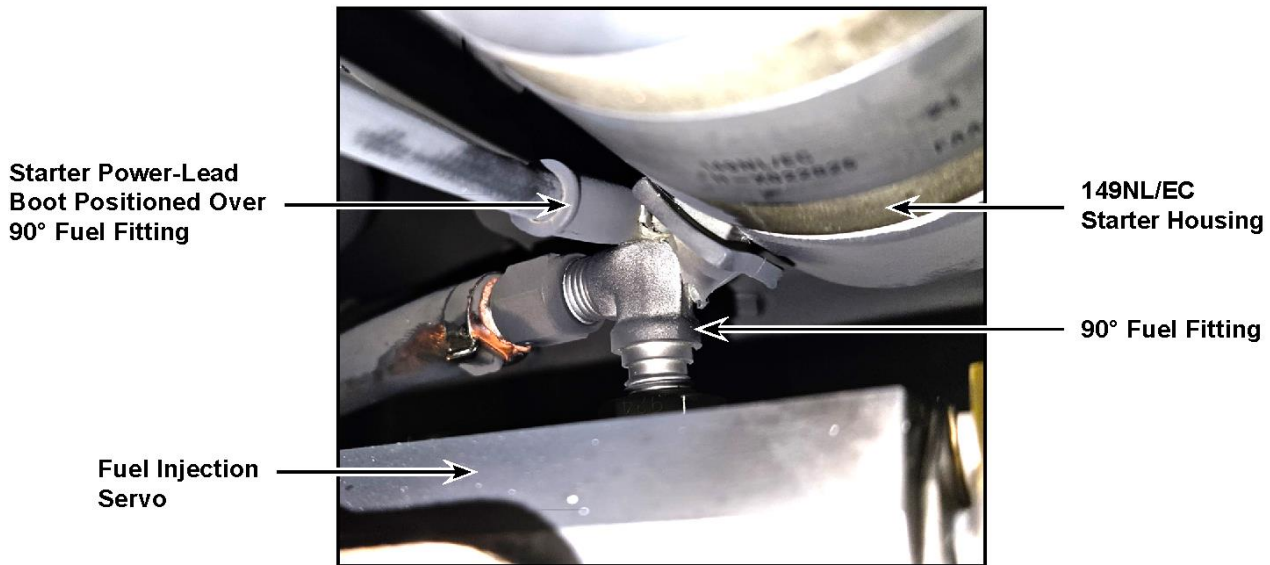
This Mandatory Service Bulletin (MSB) transmits HET Service Bulletin No. 211 to ensure that owners, operators, and maintenance providers of Lycoming engines are aware of a potential condition where the power-lead on the starter may contact a fuel fitting on the fuel injection servo. It also entails inspection criteria to identify proper and improper starter installations of affected starter models when installed on a Lycoming engine equipped with a forward-facing fuel injection servo with a top mounted 90° fuel fitting. If improperly installed, the electrical insulation on the power-lead and boot may become damaged resulting in a short-circuit when the starter is energized. This condition may result in a fuel leak if the short-circuit damages the fuel hose assembly connected to the 90° fitting.

- (1) Hartzell Engine Tech has discovered that affected starter models, when installed on engines containing a fuel injection servo with a top mounted 90° fuel fitting, may have an improper installation.
- (2) This SB is to advise the field of a potential condition and to supply inspection criteria to identify proper and improper starter installations.

Figure-1 - **Improper** Starter Installation

1) Starters found with an improper installation (Fig. 1):

a) Remove the starter assembly in accordance with the latest aircraft/engine maintenance manual and service instructions.

b) Visually inspect the starter power-lead and boot for damage, e.g., chaffing, tears, heat damage, or exposed wire core.

1: If the starter power-lead and/or boot is damaged, replace the starter in accordance with the latest aircraft/engine maintenance manual and service instructions.

2: If the starter power-lead and boot are not damaged, re-install the starter onto the engine.

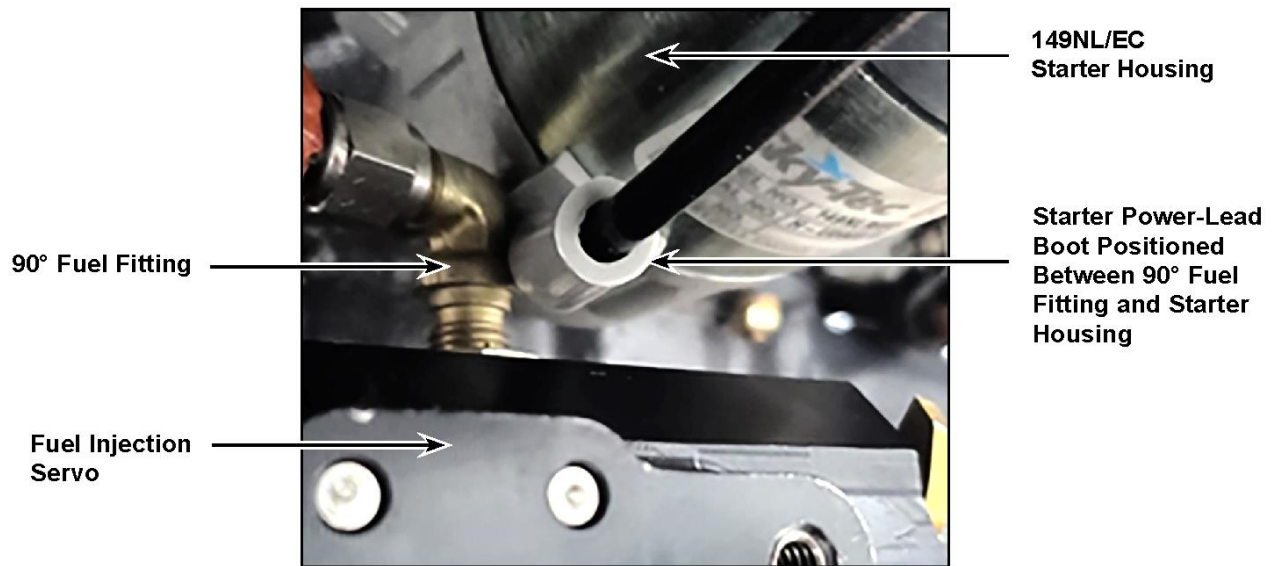
Figure-2 - **Proper** Starter Installation

WARNING: TO PREVENT DAMAGE TO THE STARTER AND/OR AIRCRAFT, ENSURE TO POSITION THE STARTER POWER-LEAD BOOT BETWEEN THE FUEL INJECTION SERVO 90° FUEL FITTING AND THE STARTER HOUSING, AS SHOWN IN FIG. 2.

2) Starters found with a proper installation (Fig. 2):

a) Inspect the starter power-lead and boot for damage, e.g., chaffing, tears, heat damage, or exposed wire core.

1: If the starter power-lead and/or boot is damaged, replace the starter in accordance with the latest aircraft/engine maintenance manual and service instructions.
